## Drill-less installation Instructions for 2007–2019 Chevy / GMC 1500/2500-3500 Single Rear Wheel

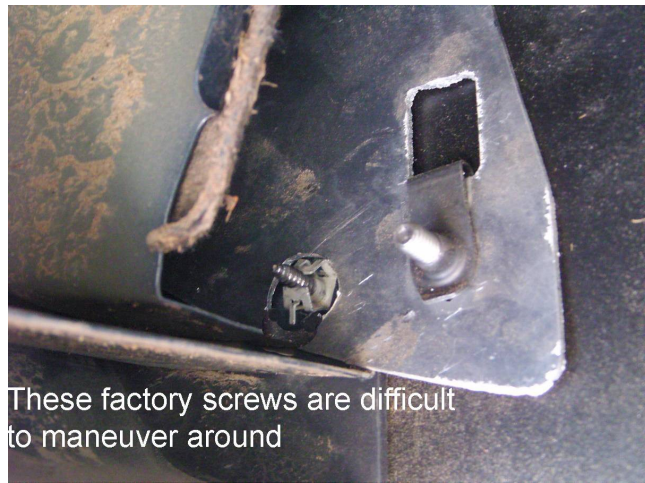
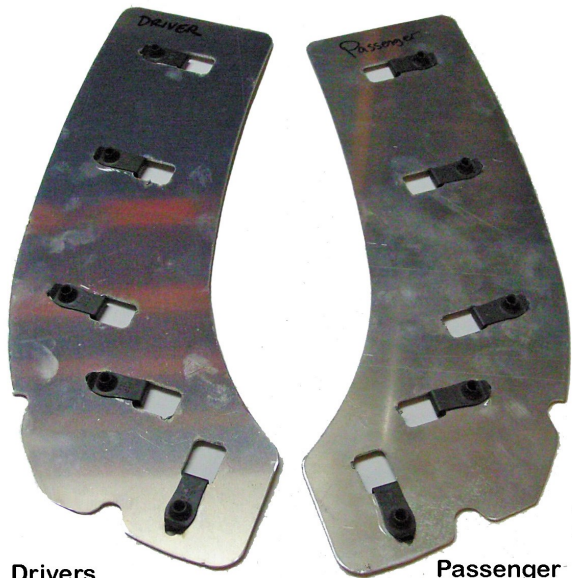
Drivers  
Passenger  
2014-2018 1500 and 2015-2019 2500/3500 brackets

**Note:** On the 2014-18 1500 and 2015-19 2500/3500 Chevy trucks, you will need to finesse the bracket over the 2 factory screws holding the trim ring on the bottom of the fender well at points G and H. There are cut outs in the bracket to line up with these screws at points G and H.

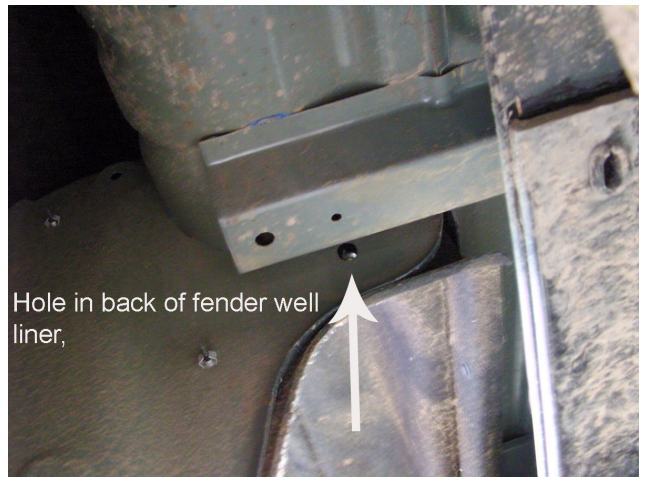
Hole in back of fender well liner,

Step 2: \*If you have a fender well liner, you will need to punch a hole through the liner to access attachment point F; this attachment point cannot be overlooked. You can find the factory hole from the back as shown in the image on the back.
